Memorandum

Date: *August 15, 2014*

Subject: *Oversight Summary Report
CPG Oversight of RM 10.9 Removal Action
Lower Passaic River Restoration Project*

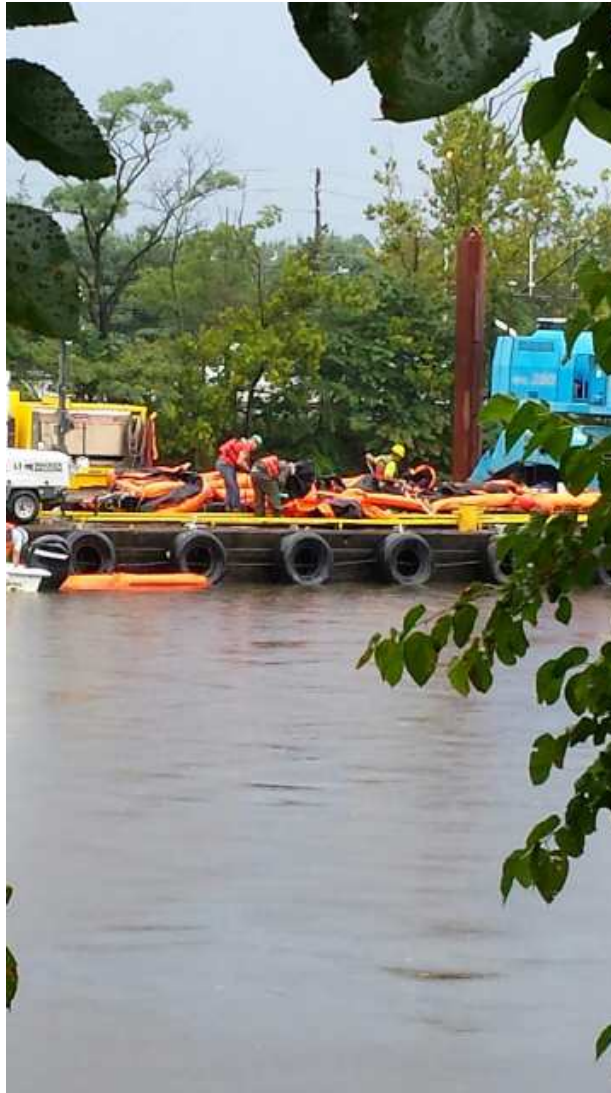
August 22, 2013: Damaged silt curtain collected on barge

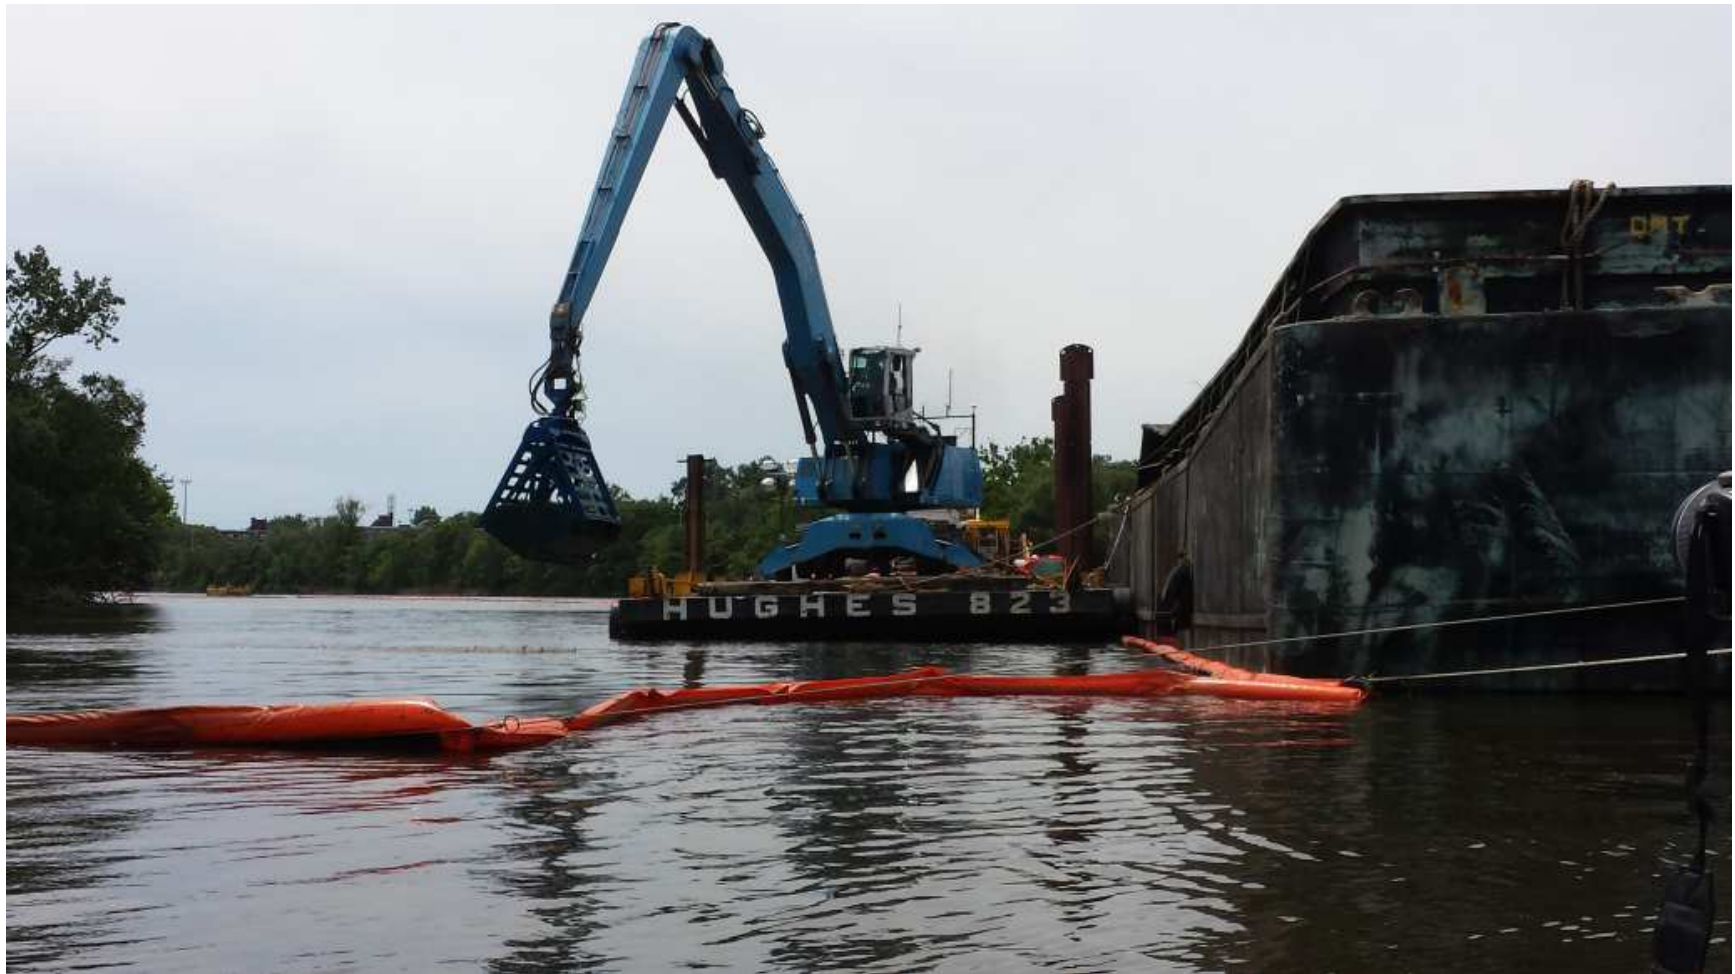
August 23, 2013: Good seal observed on dredge bucket

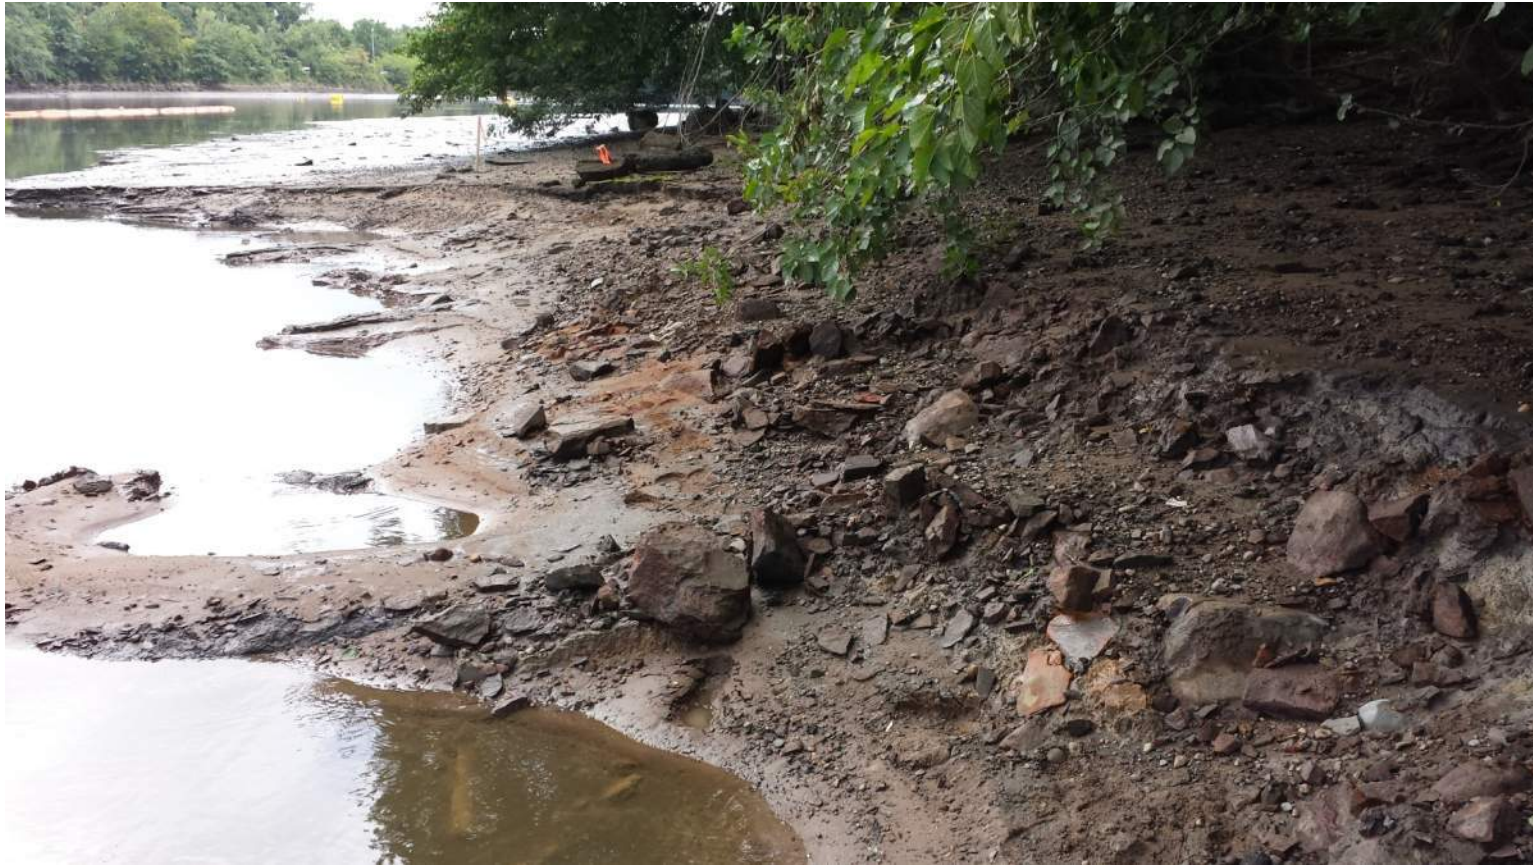
Fractured Rock Outcrop

GLDD reported that there were several locations along the eastern riverbank in Area 1 where rock outcroppings extended above the 2-foot dredge line, preventing dredging to the target depth. Oversight personnel visited the area on August 27 and observed the refusal area. Rock and hard clay were visible, though it was difficult to determine the lateral extent of the hard material.

Looking in the direction of the Rt. 3 bridge this is what is exposed at high tide in section 4T of Area 1.

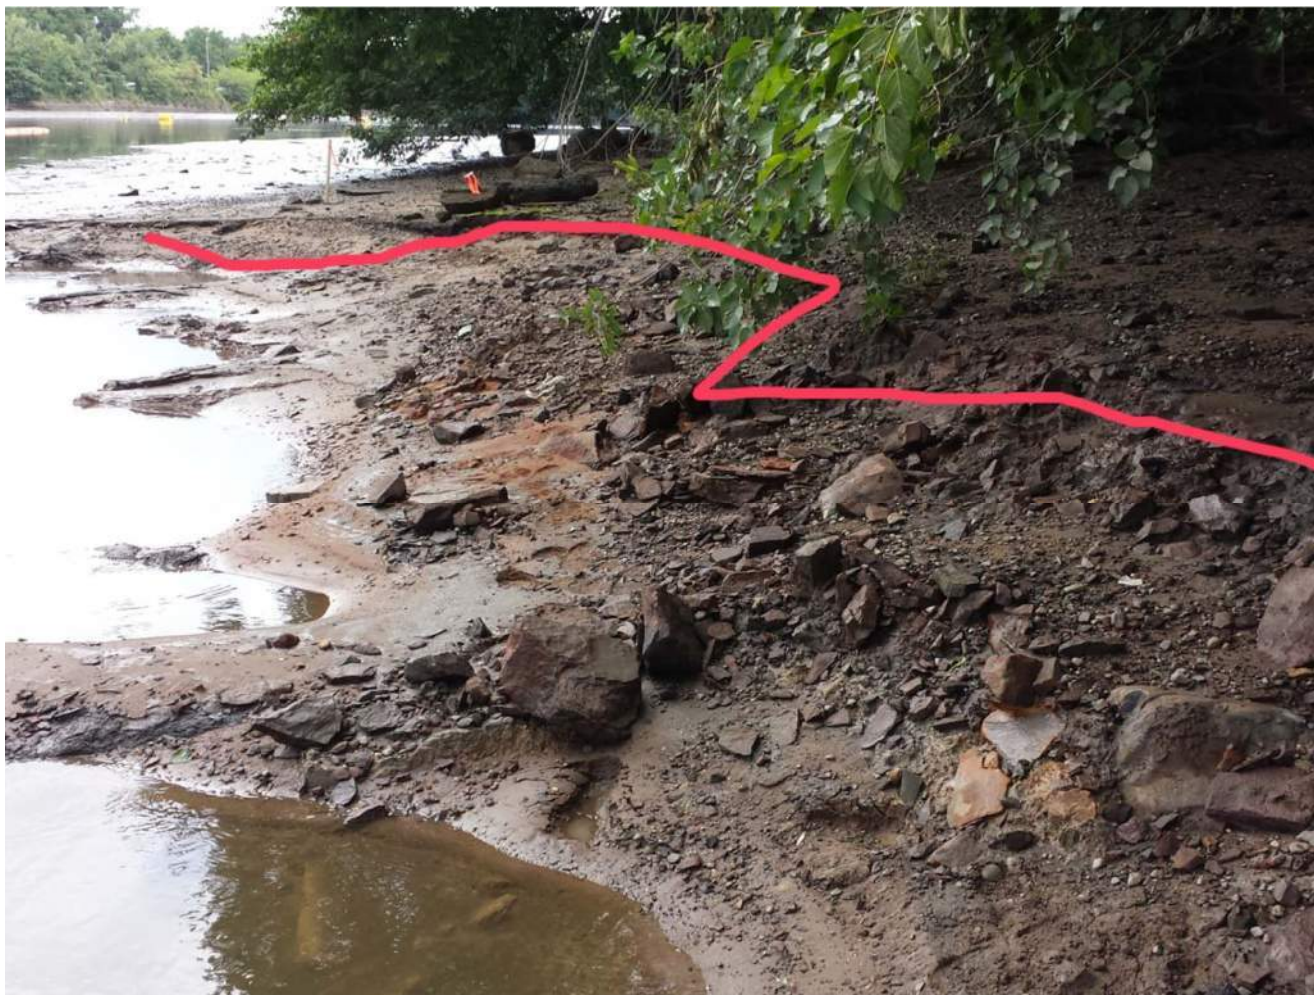
Fractured Rock Outcrop

Same picture as before with outcropping highlighted in red.

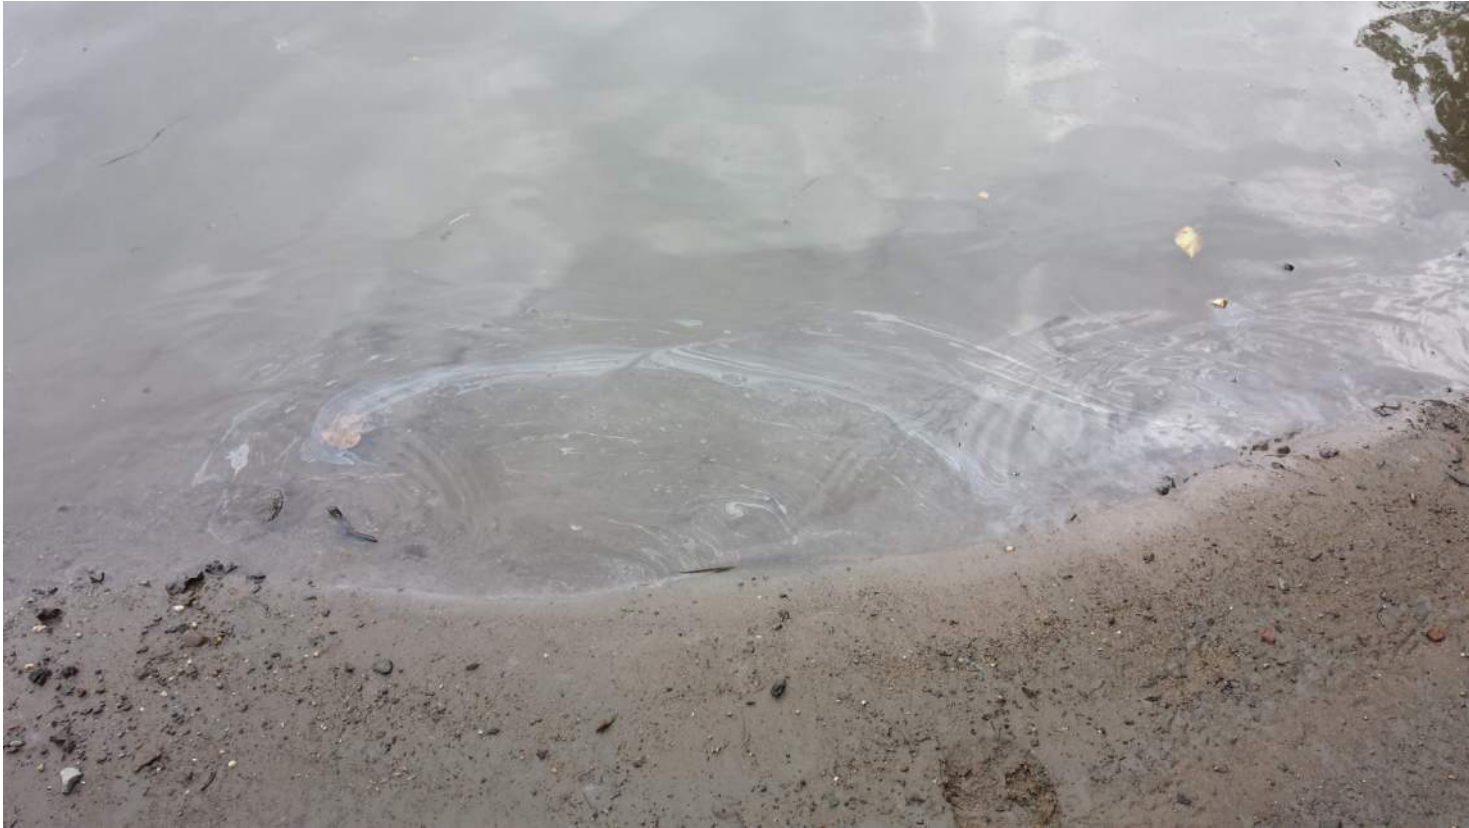
Sheen at water line

This sheen was observed as the tide was coming in. Was able to run a stick through it to confirm it's of petrol base. No dredging was occurring at this time. Sheen ran along waterline.

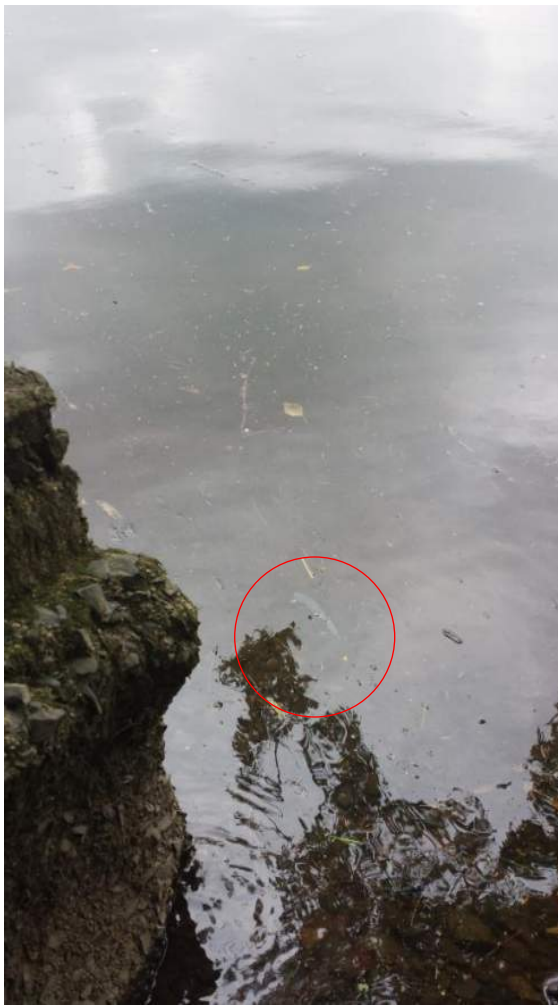
Sheen as Tide comes in

Example of the minimal sheens observed as the tide comes in.

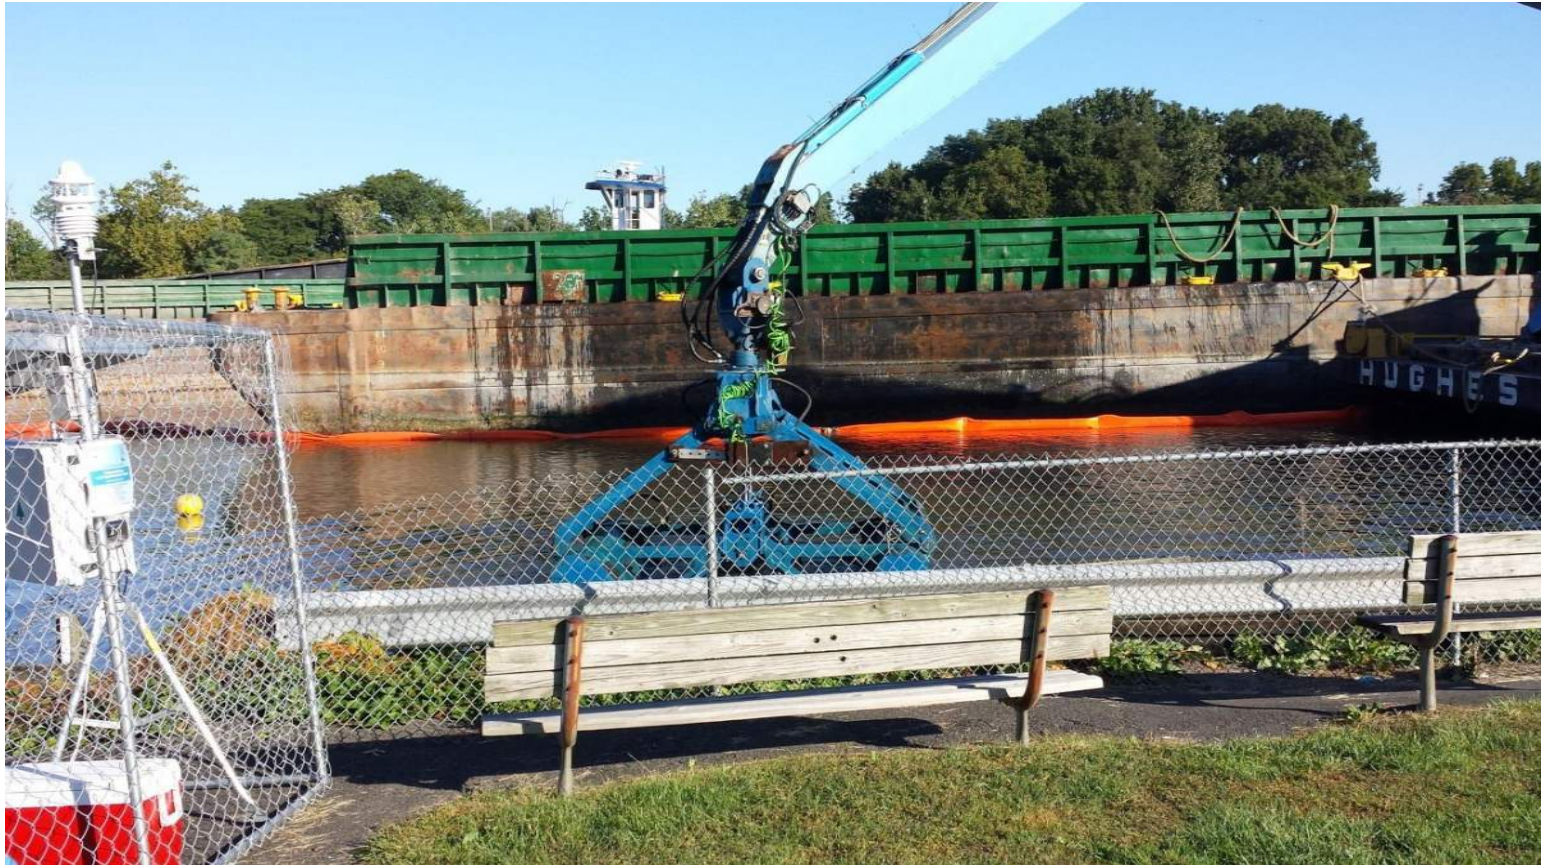
0920 Dredge Location

At this location is where the odor and sheen were observed. I was unable to get a good picture of the sheens.

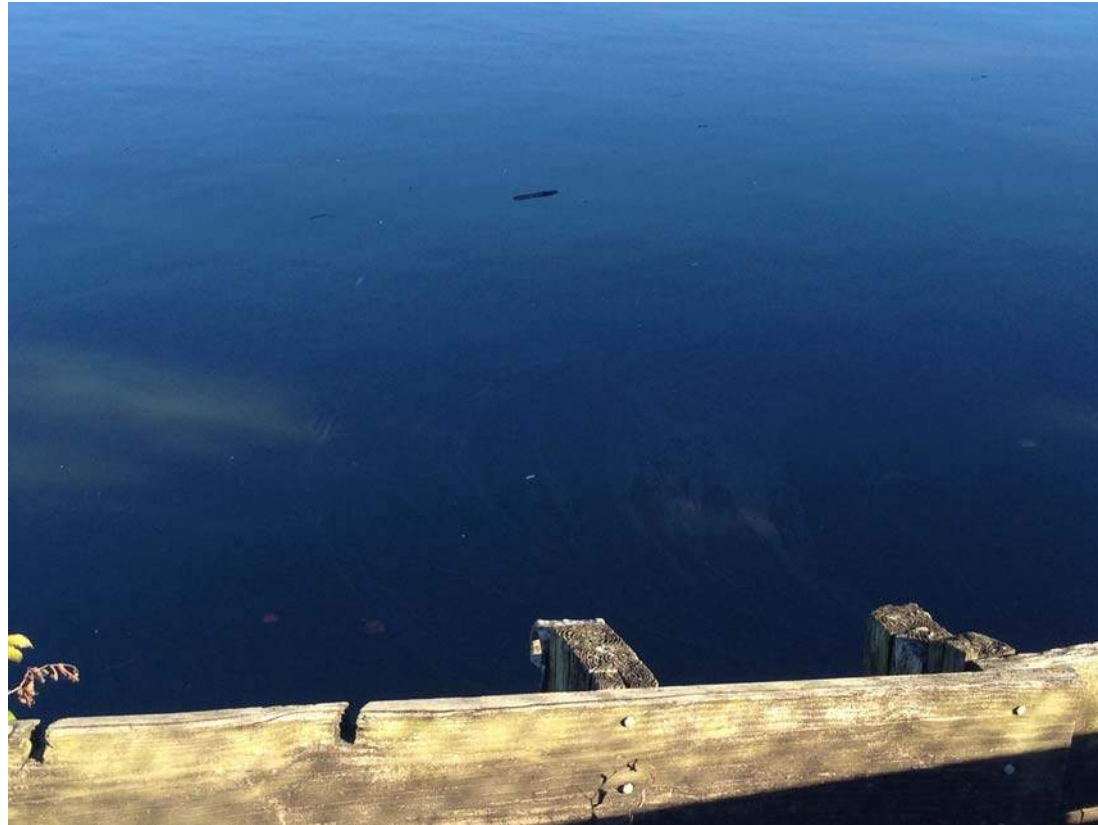
Sheen Near Boat Launch

A slight sheen on the river surface was observed around 0830 but was no longer visible by mid-morning. This has happened before, and was brought to the attention of the CPG representative. They are prepared to take further action (set up booms) if it ever were to become more severe.

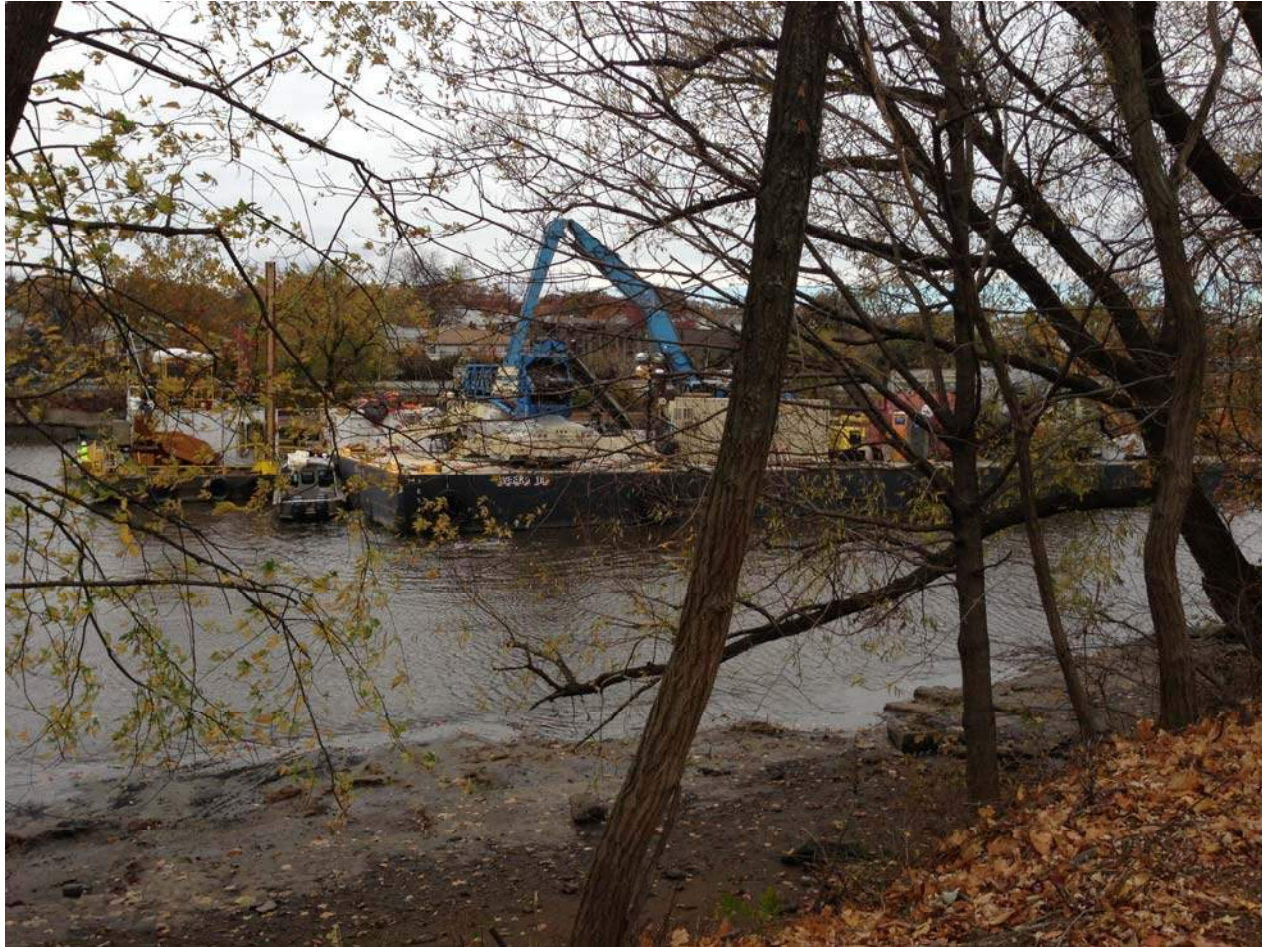
Capping Delay

November 10 – November 16, 2013. Full-scale continuous capping operations began on November 15. Work was delayed early in the week due to malfunctioning of the on-barge generator used to power the sand hopper. Attempts to repair the original generator were unsuccessful and a replacement was delivered to the site on November 15.

There was no capping at RM 10.9 today. The barges and scows remain at the southern end of the capping area. A generator associated with the hopper is being replaced and should be operable by tomorrow (Wednesday, November 13, 2013) morning.

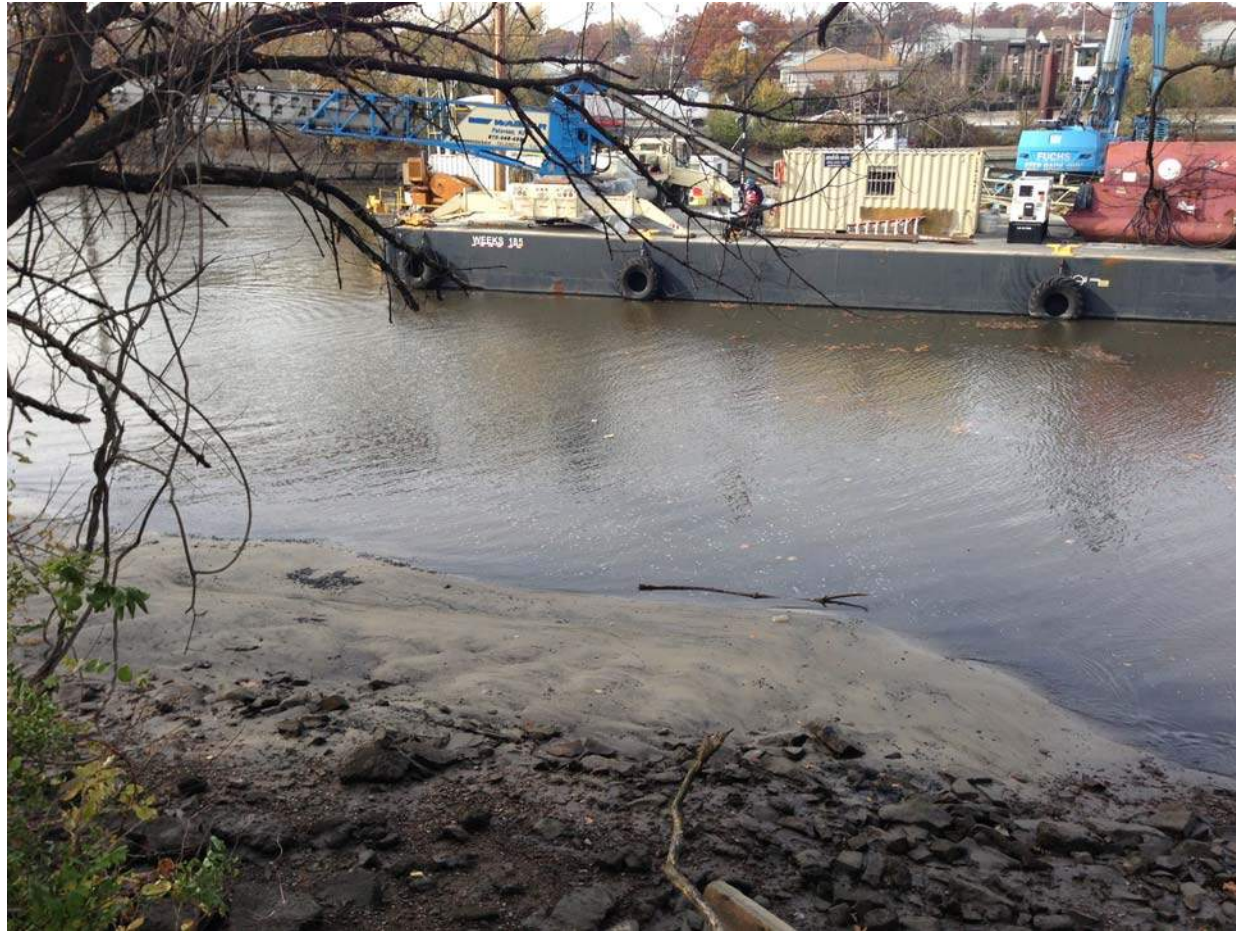
Aquagate Placement

The shallow water turns dark when Aquagate is first deposited, suggesting some amount of carbon suspension. Furthermore, when one of the GLDD workers planted an oar in the capped sediment a small black plume was observed from the carbon in the Aquagate.

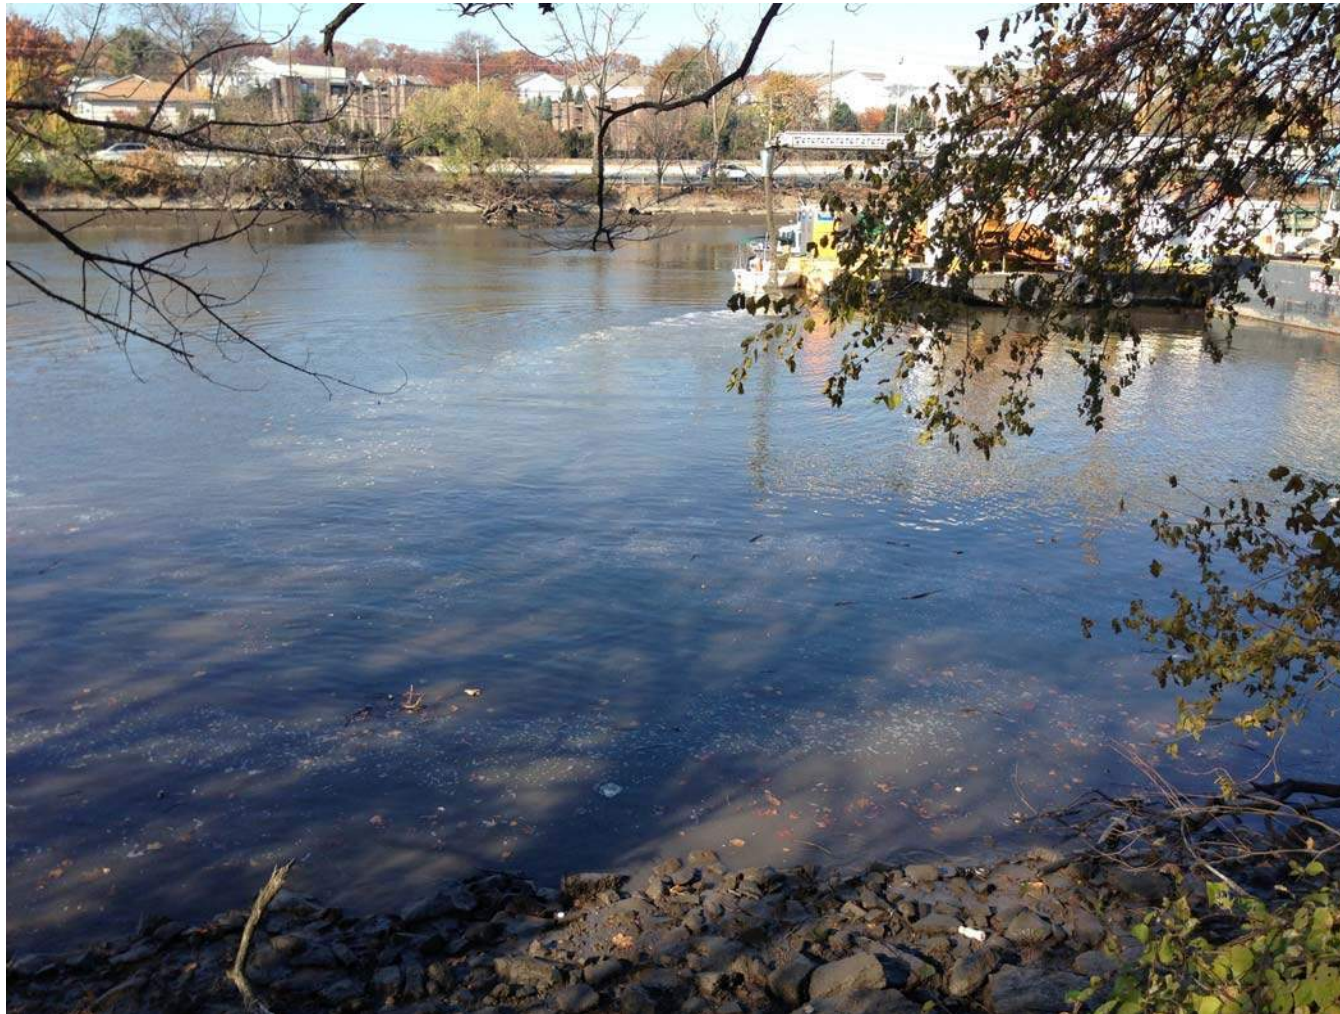
Turbidity Plumes

Turbidity plumes such as the one shown above are not uncommon. They begin to dissipate quickly, however, and do not cause elevated turbidity readings at the downstream buoys.

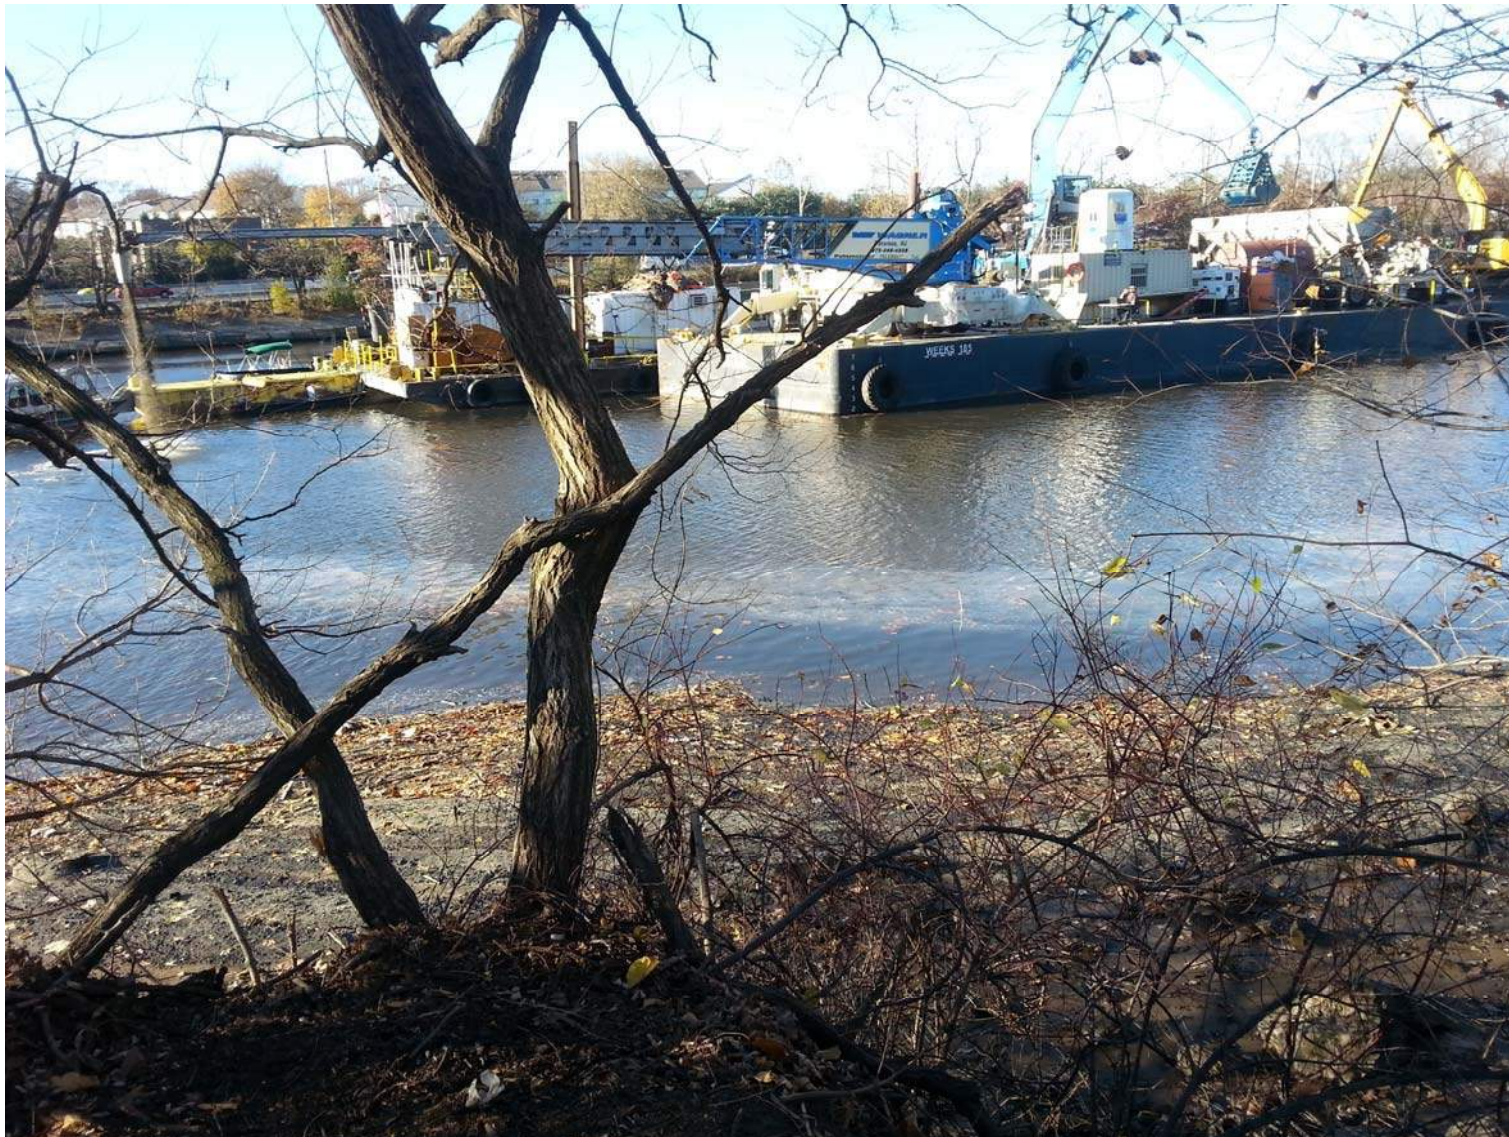
November 18, 2013 1445: GLDD placing Sand/Aquagate cap, a slight turbidity plume is observed. The plume migration is limited to approximately 5-10 ft away from the location of placement.

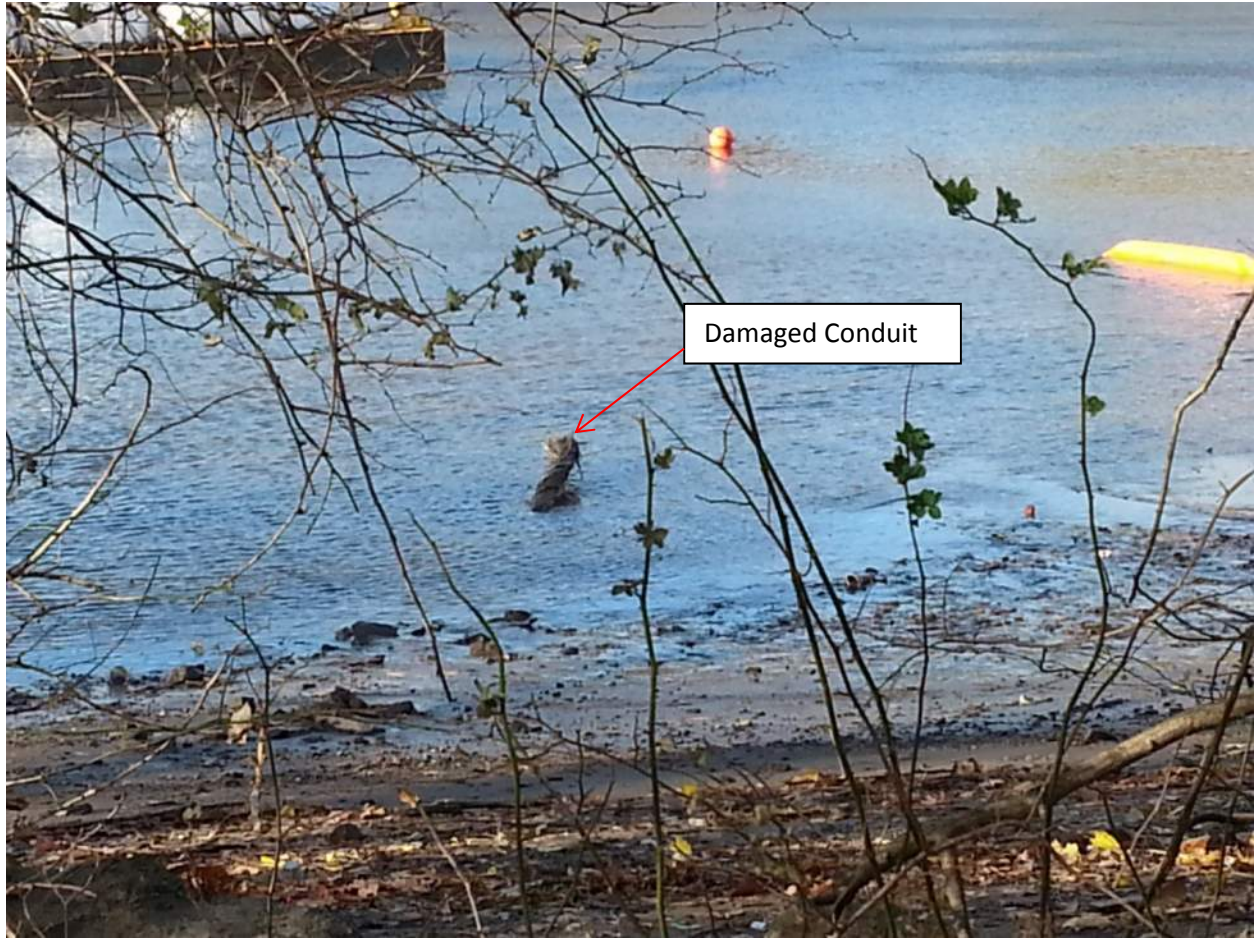
On November 19, oversight personnel observed a damaged conduit of unknown origin or purpose protruding from the No Dredge Zone at low tide. It was determined to be an abandoned utility cable and it was removed by the CPG late on November 21.

November 19, 2013 1400: Conduit that was damaged during dredging activities.

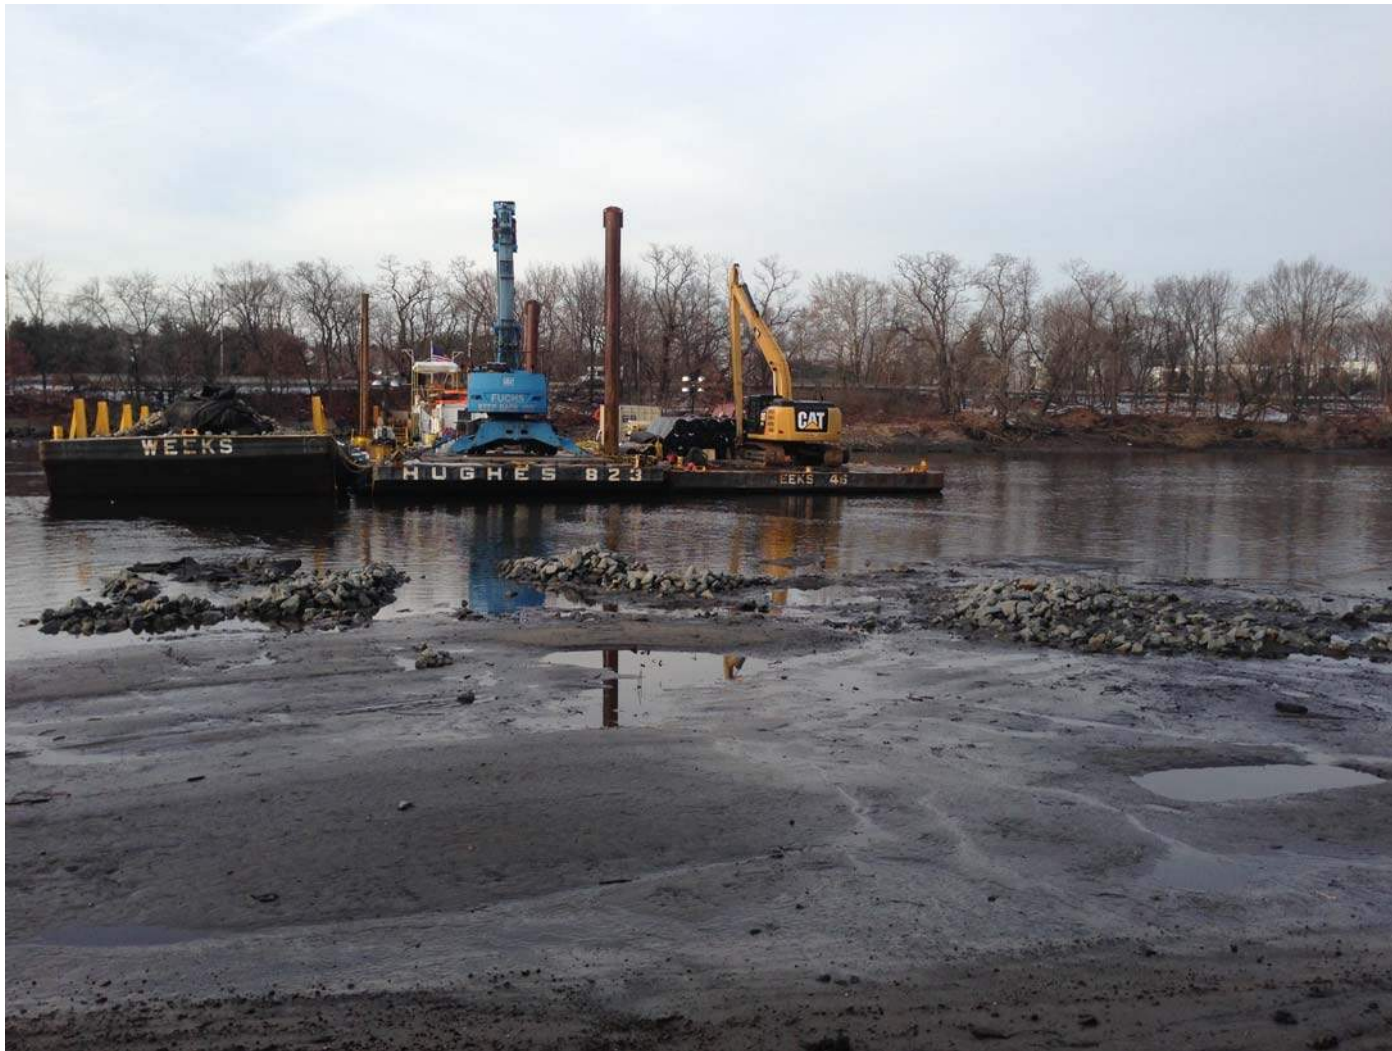
Residual Armor Stone

The armor stone that was previously placed atop the geotextile fabric was not removed. It will need to be removed prior to the next attempt at geotextile placement. There was no clear evidence of damage to the active layer during the fabric removal, but only the non-submerged area could be judged.

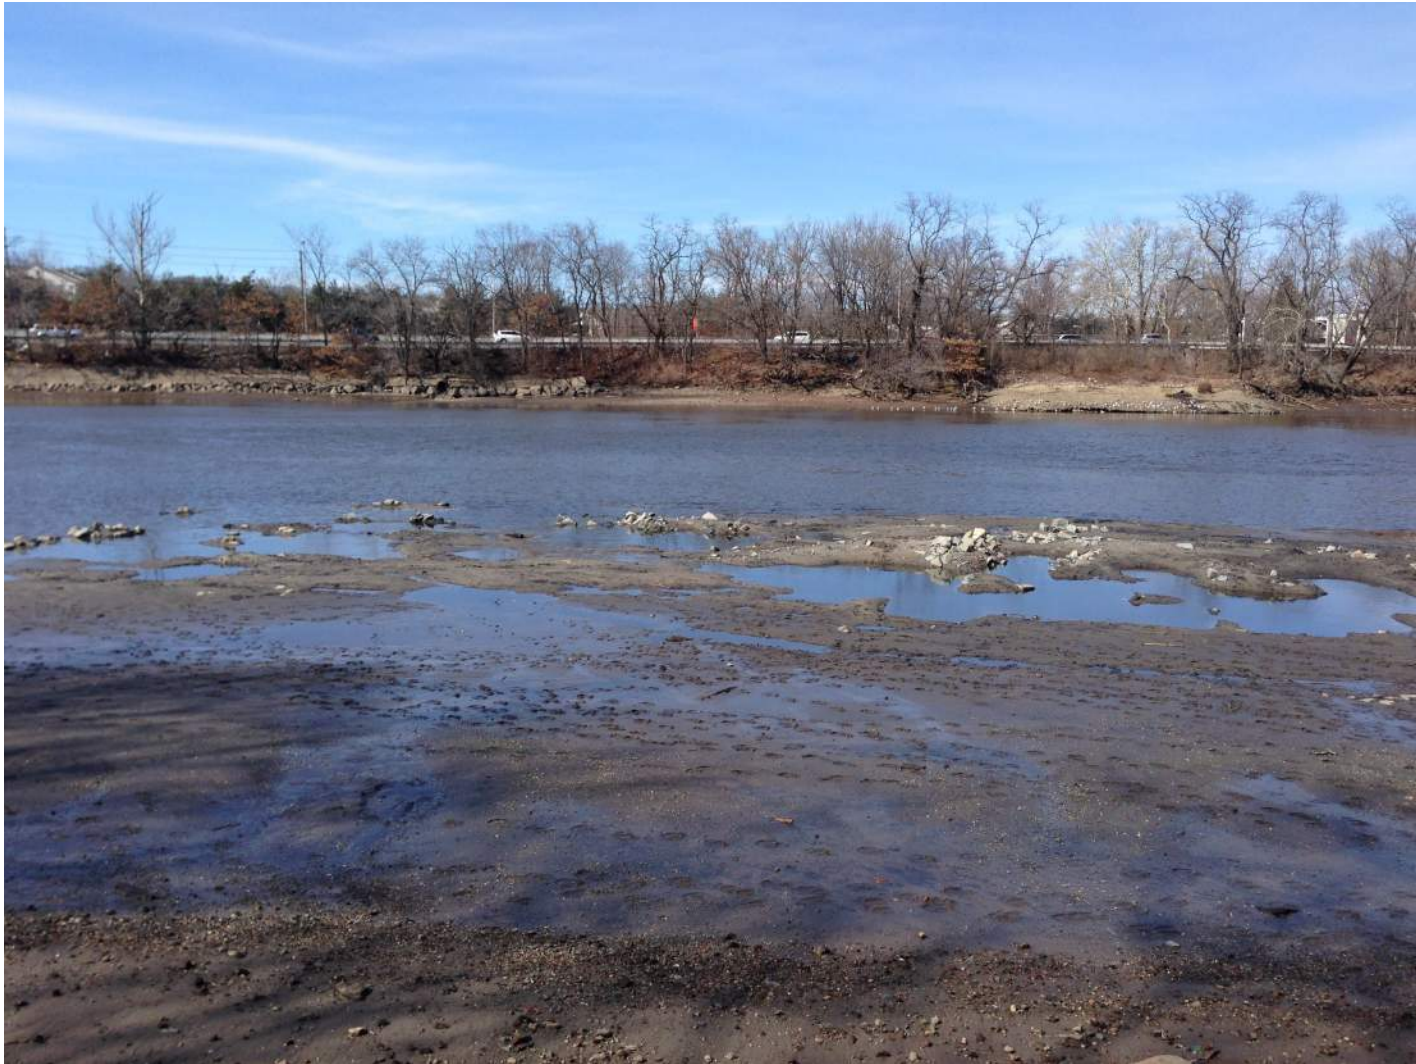
Remaining Stone After Removal Operation

Some armor stone was observed at low tide in the area where, on Tuesday, GLDD performed stone removal with the rock sifting fork. They will likely need to remove this rock and also take measurements of active layer thickness before geotextile is installed here.

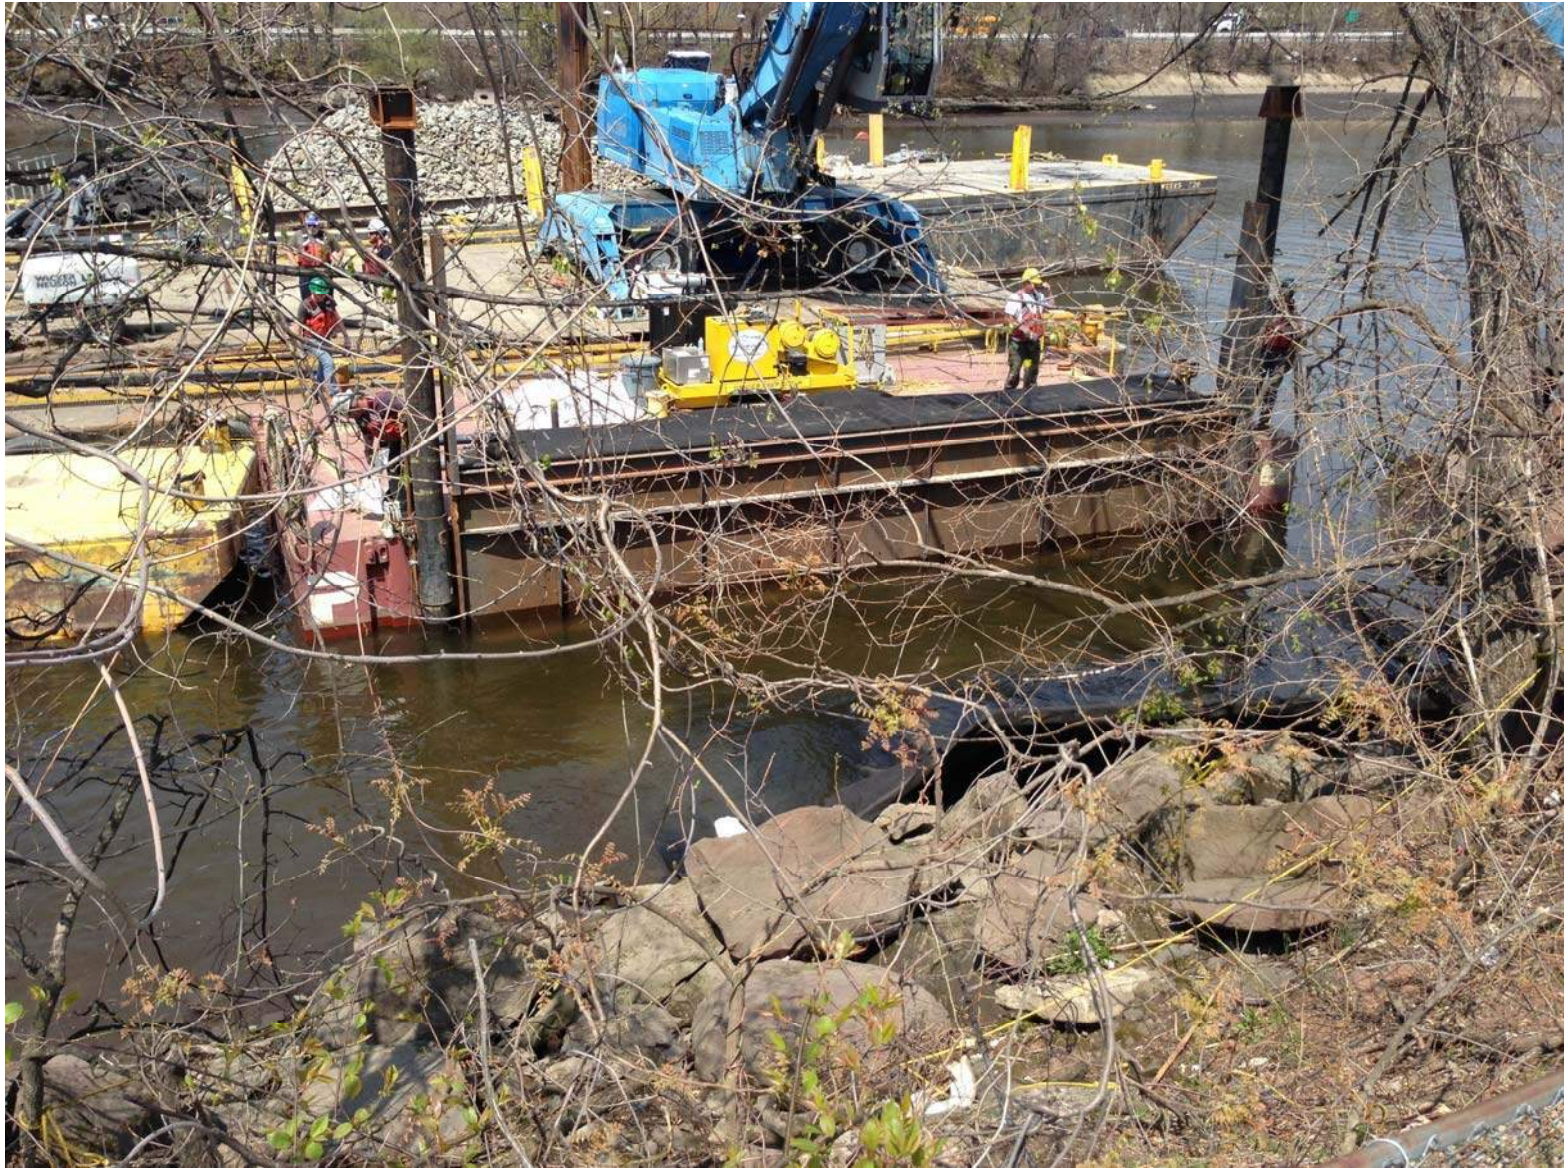
Geotextile Panel 39-N Installation

GLDD successfully installed panel 39-N, which was the location of the slope failure in February. They placed additional sand/AquaGate prior to the fabric installation.

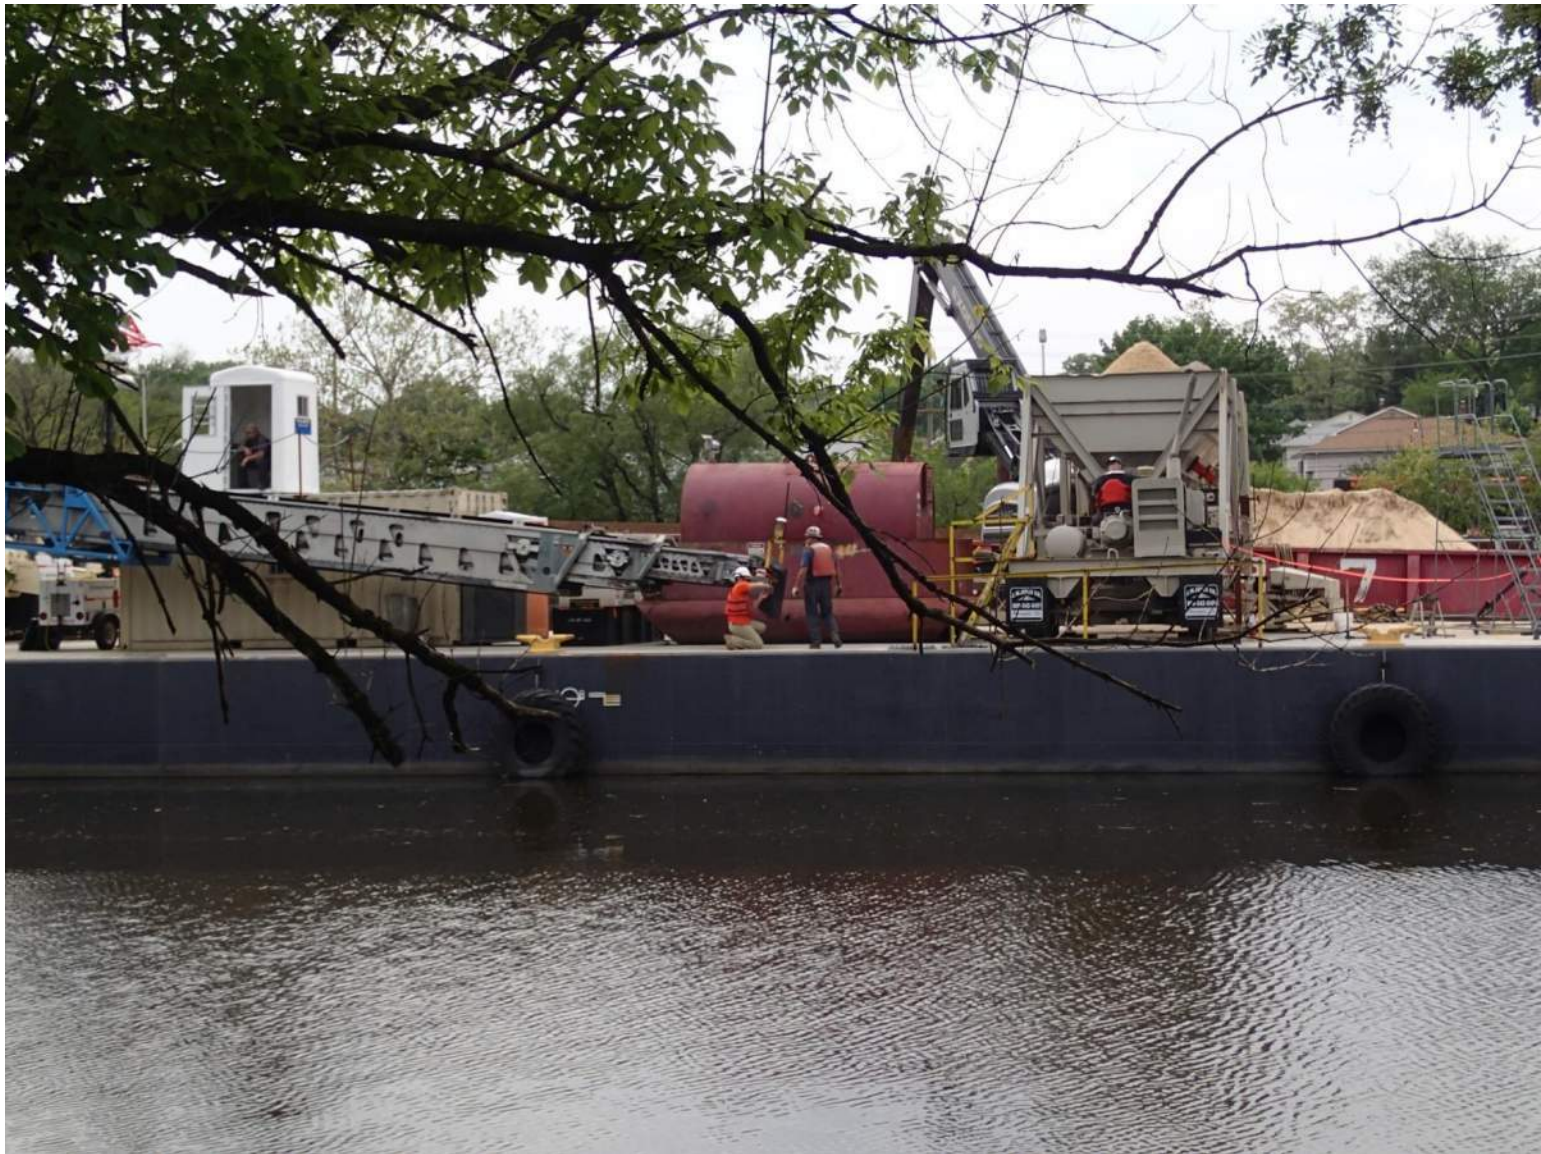
Telebelt Repairs

15:51 – Work stopped while GLDD crew addresses GPS issues with the Telebelt.
